# Test a WR44v1 Router

How to test a WR44v1 router step by step.

Technical Support March 2016

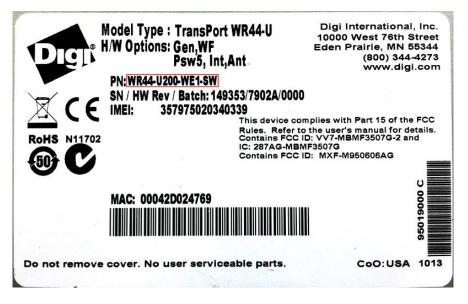
It is critical that the correct selection is made at this point. Note characters 6 and 7 of the part number (SKU) on the approval label. In the example below these are "U2":

Refer to the following table to determine which selection to make:

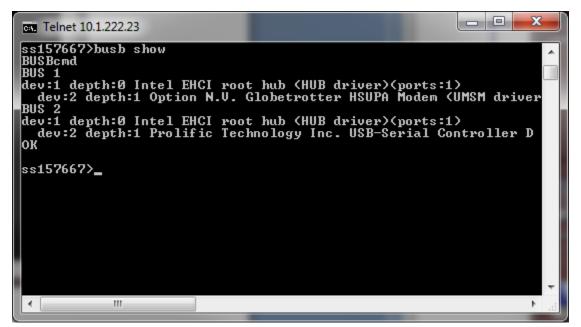
Access the CLI (Command Line Interface) and issue the "busb show" command:

2 devices should normally be present:

- Device in "BUS 1, dev2, depth 1" (This is an Option radio module, do not be concerned if it is missing, the module may be mid power cycle. The text of this will vary based upon the type of module fitted.)
- Device in "BUS 2, dev2, depth 1"
