# **Test a WR44v2 Router**

How to test a WR44v2 router step by step.

Technical Support December 2018

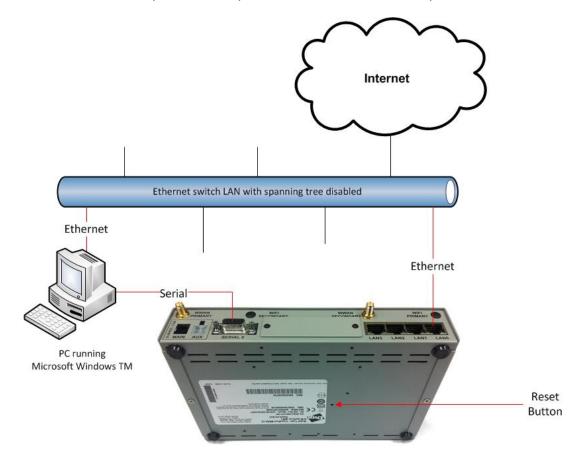
Set up the test equipment as described below.

- Connect LAN 0 of the WR44V2 to the switch/hub.
- Connect "ASY 0" the WR44V2 to the PC's serial port 0 ideally "COM 1".
- The Internet connection is optional and will be useful if help is required during this process from Digi Technical Support.
- Please note that the Ethernet switch/hub must not have the spanning tree protocol enabled. It is possible to use another appropriately configured WR44V2 as a switch/hub.
- It is essential that the PC's Ethernet communication interface is configured correctly and has an IP address. The best strategy is normally to connect both your PC and the WR44V2 to your normal office LAN.
- Locate a suitable implement to depress the reset button when required.

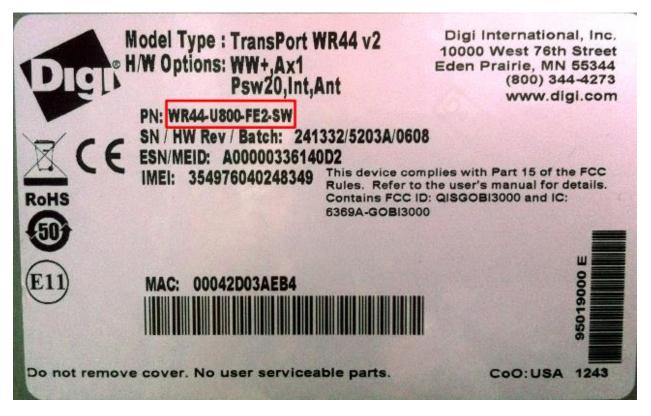
Note 2: characters 6 and 7 of the part number (SKU) on the approval label. In the example below these are "U8":

Characters 6 & 7	Flashwriter Selection
00	100 No module
G1	5 Cinterion/Siemens MC75i/TC63i/MC75/Triorail
E1	5 Cinterion/Siemens MC75i/TC63i/MC75/Triorail
H0	9 Option HSDPA/HSUPA modules
H1	9 Option HSDPA/HSUPA modules
H2	9 Option HSDPA/HSUPA modules
C0	10 CMotech CDMA module
C1	11 Sierra Wireless CDMA module
C2	11 Sierra Wireless CDMA module
C3	10 CMotech CDMA module
C4	10 CMotech CDMA module
C6	10 CMotech CDMA module
C7	10 CMotech CDMA module
U0	9 Option HSDPA/HSUPA modules
U1	9 Option HSDPA/HSUPA modules
U2	13 Ericsson F3507g/F3607gw/F3307/F5521gw HSDPA module
U3	7 Sierra Wireless 3G module
U4	13 Ericsson F3507g/F3607gw/F3307/F5521gw HSDPA module
U5	17 Gobi UMTS or 18 Gobi CDMA
U6	13 Ericsson F3507g/F3607gw/F3307/F5521gw HSDPA module
U7	13 Ericsson F3507g/F3607gw/F3307/F5521gw HSDPA module
U8	17 Gobi UMTS
U9	24 Telit 3G
L1	28 Huawei LTE
L2	23 Novatel LTE
L3	23 Novatel LTE
L4	26 Sierra Wireless 4G/LTE module
L5	26 Sierra Wireless 4G/LTE module

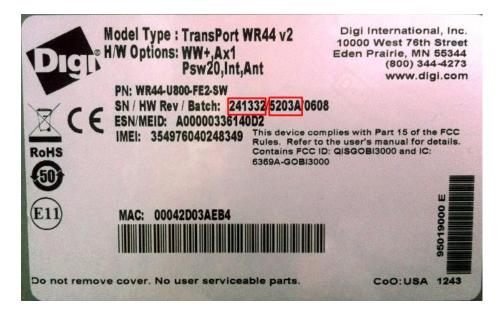
Eventually you should be prompted to enter the 6 digit serial number. (Refer to the label under the WR44V2 to find the correct serial number.)

Manual Serial Number Entry	×
Enter the serial number:	ОК
	Cancel
205017
